National Transportation Safety Board

Highway Accident Brief

School Bus Roadway Departure

Accident Number:	HWY14FH010
Accident Type:	School bus roadway departure
Location:	Nohl Ranch Canyon Road, Anaheim, Orange County, California
Date and Time:	April 24, 2014, about 3:37 p.m. Pacific daylight time
Vehicles:	2012 Blue Bird 78-passenger school bus
Fatalities:	0
Injuries:	10 (5 serious, 5 minor)

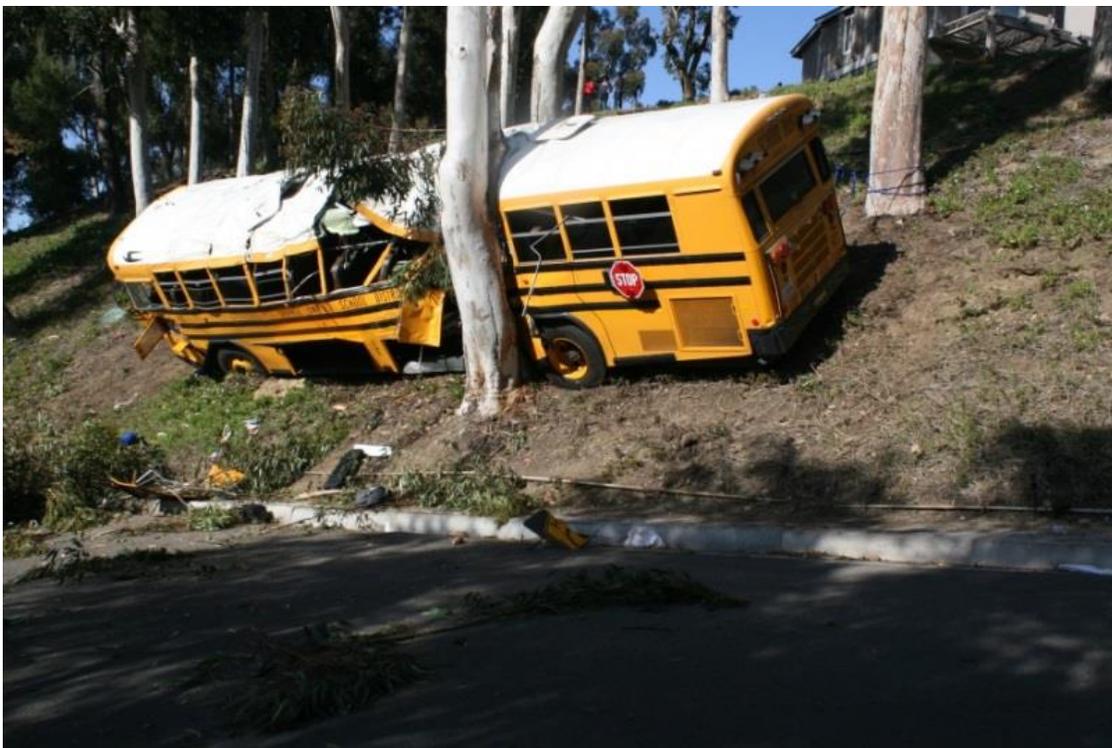
Figure 2. Photograph showing the school bus at final rest (Source: Anaheim Police Department)

According to witnesses, while the school bus was traveling downhill on Nohl Ranch Canyon Road, its speed increased and it traveled out of its lane to the right. The bus left the roadway and overrode the right curb, where it struck and dislodged a concrete light post. The bus continued up an embankment, where its front struck and uprooted a tree. The left side of the bus also scraped along a large tree from approximately the front axle to the rear axle. The bus came to rest at an approximate 30-degree angle on the embankment, leaning onto this same tree, which was in contact with the left side of the bus just aft of the left-side emergency exit door and just forward of the rear wheels. (Figure 1 maps the location of the crash, and figure 2 shows the bus at final rest.)

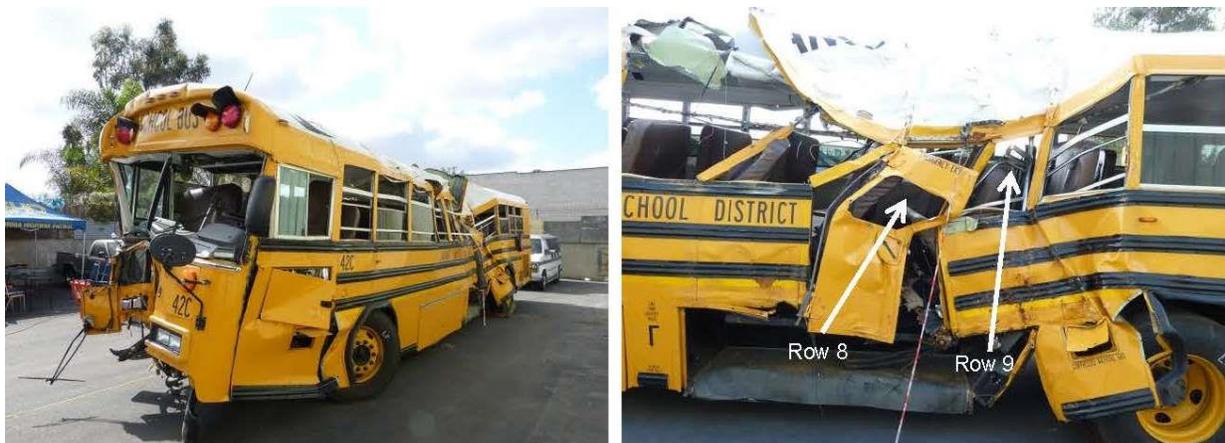
The front of the bus sustained damage from impacts with a light pole and two trees during the crash sequence. As shown in figure 3, the front end damage occurred predominantly on the right front corner of the bus as a result of the impact with a tree, with intrusion into the loading stairs. The front loading door located on the right side of the bus was inoperable as a result of the crash. The area immediately surrounding the driver's seat was not compromised by this intrusion damage.

Figure 3. Front and left side postcrash views of the bus.

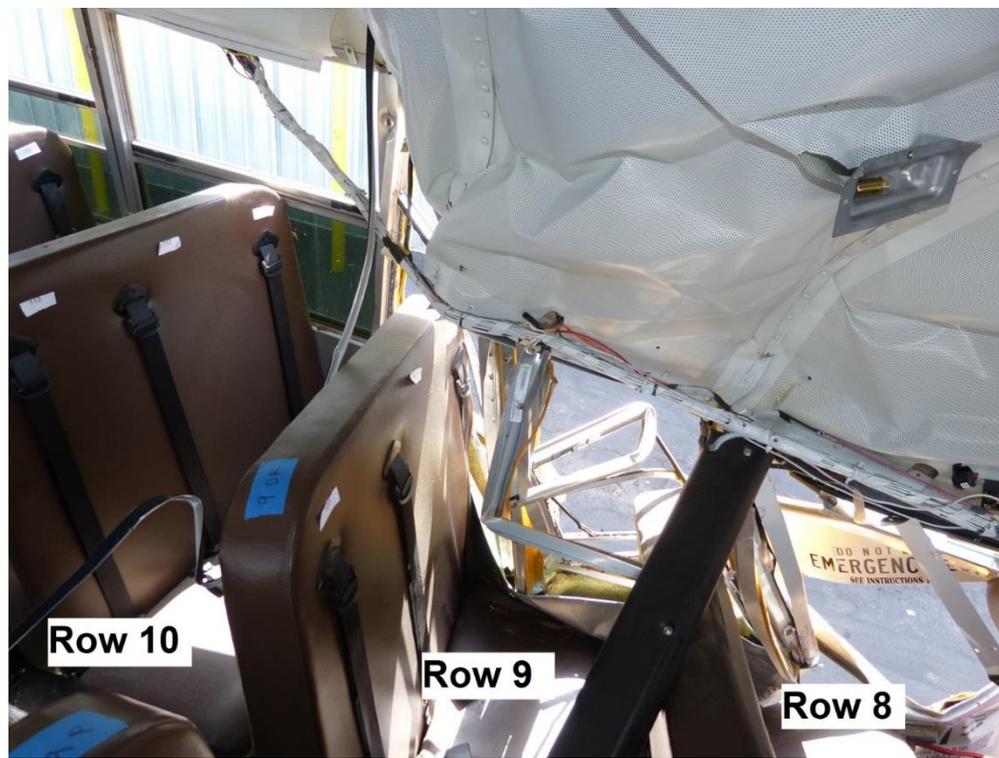
The left side of the bus scraped along a large tree, causing damage from the front axle aft to the rear axle. This tree caused significant intrusion along the left side and roof of the bus, with maximum penetration into the passenger compartment at seat rows 7 through 9. The left-side emergency exit door, at row 8, was partially dislodged from the bus. The left sidewall and roof in the area of rows 7 to 9 were crushed inward, with portions of the roof crushed down to the level of the seatbacks and inward up to half the width of the seats. Figure 4 shows the interior intrusion into rows 8 and 9 with a view looking from the right side interior of the bus toward the left side. The intrusion resulting from the left side of the bus scraping the tree caused multiple seats in rows 6–9 to be displaced inboard to the extent that they blocked the center aisle.

Figure 4. Interior view of the bus showing left side rows 10, 9, and 8.

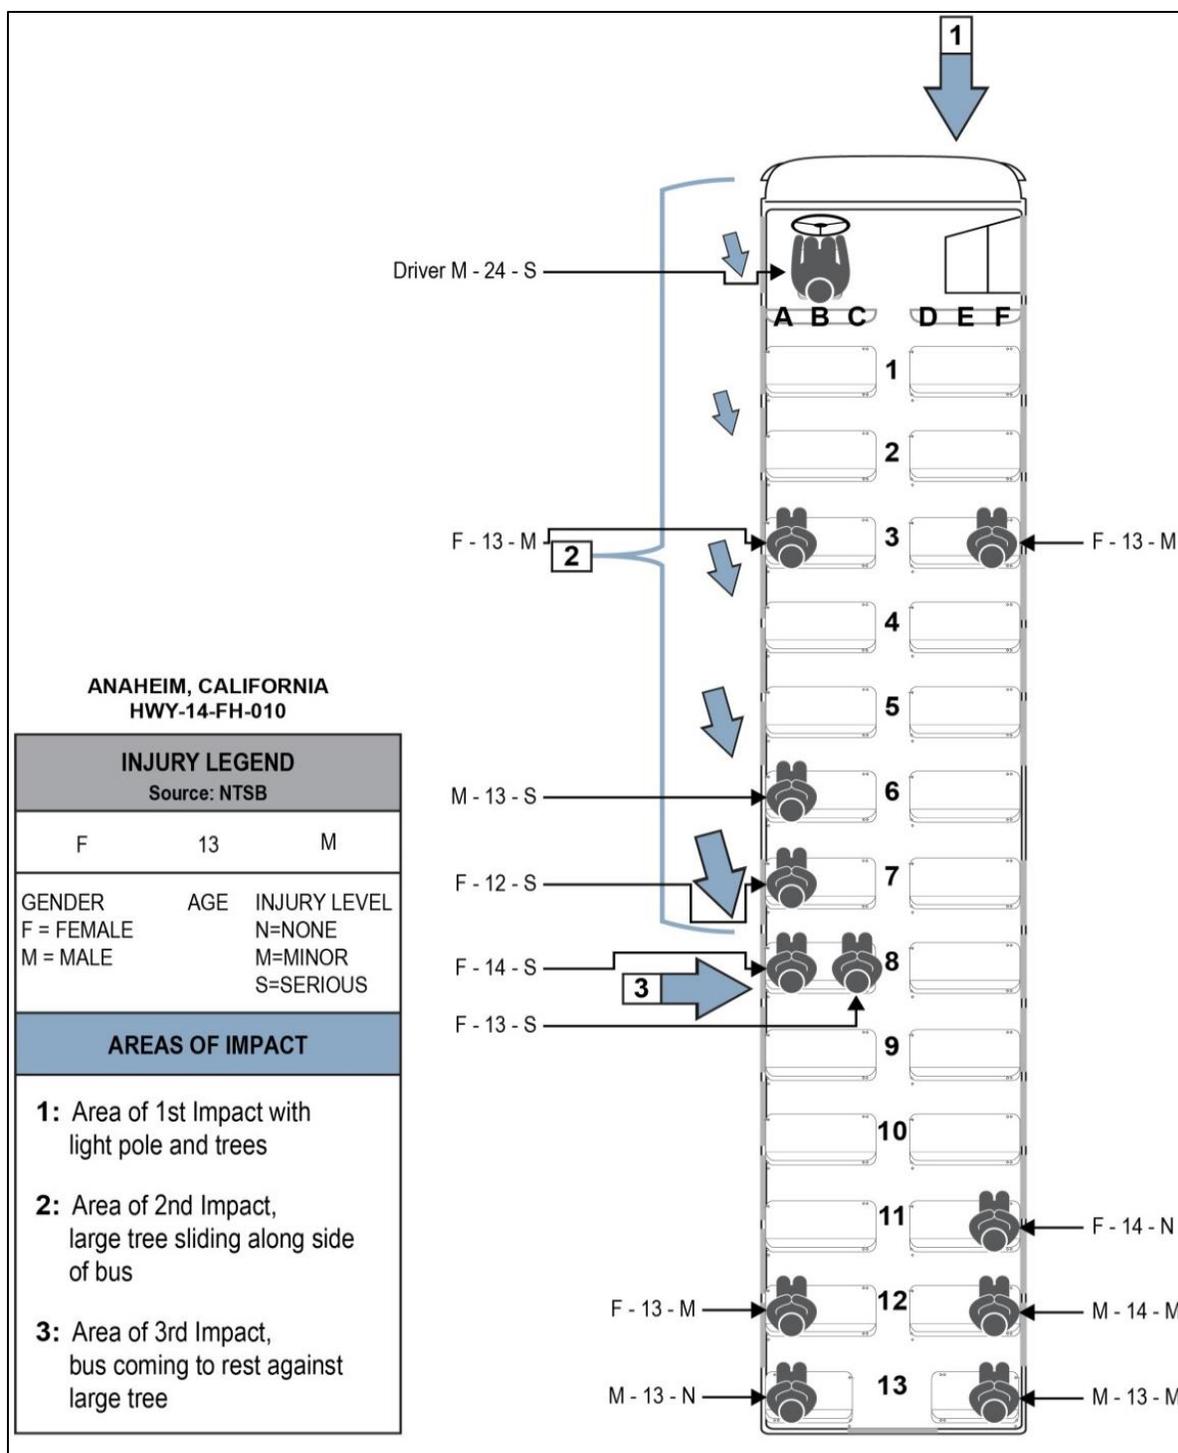
Table 1 summarizes the injuries experienced by the driver and the 11 student passengers. Figure 5 provides a seating diagram and information on the age, gender, and injury severity of the bus occupants. The driver and five students were transported to area hospitals for treatment, and the remaining six students were treated at the scene and released to parents or guardians. The arrows on the figure 5 diagram show areas of impact and areas of intrusion into the school bus.

Figure 5. Seating diagram detailing the age, gender, and injury severity of the bus occupants. The arrows show areas of impact and areas of intrusion into the school bus. The arrow designated “1” corresponds to the area of impact with the tree at the front of the bus. The arrows increasing in size down the left side of the bus and designated “2” correspond to the region of increasing intrusion from the left side of the bus scraping a tree. The arrow designated “3” marks the area of maximum intrusion by the tree on the left side.

Eleven students were on the school bus. Of these, four students were seriously injured, all of whom were seated on the left side near the middle of the bus, in seats 6A, 7A, 8A, and 8C. The student in seat 8A suffered the most serious injuries, which included three cervical fractures with spinal cord injury, skull and mandible fractures, and an open toe fracture.²² In addition, all the seriously injured students suffered fractures on the left sides of their bodies, including a left arm fracture (student in seat 6A), left clavicle fractures (students in seats 7A and 8C), and a left foot

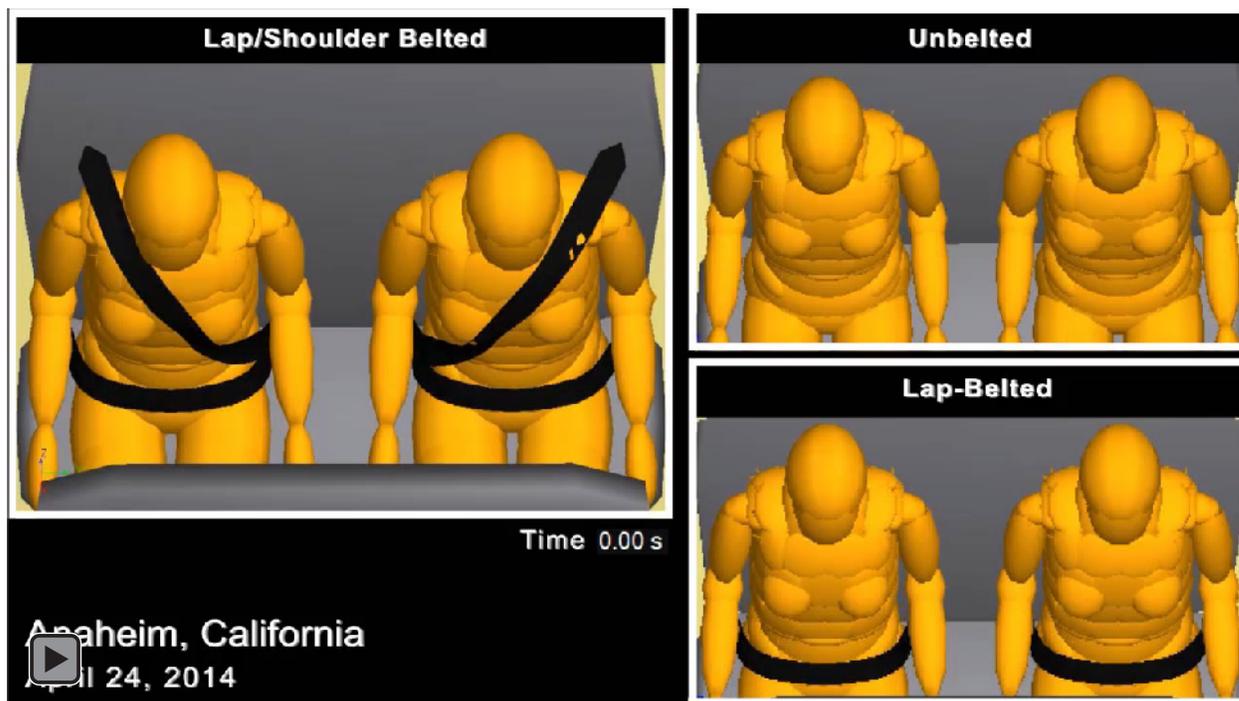
Generally, the simulations predicted the lowest injury levels for the lap/shoulder-belted occupants. (See link to video simulations below.)

Results for unbelted occupants. The simulations predicted that both unbelted occupants would have been thrown toward the area of tree intrusion, and they most likely would have been either partially or fully ejected as a result of being in that region at that time.

Results for lap-belted occupants. Although in the simulations the entire bodies of the lap-belted occupants were not thrown toward the area of tree intrusion, their upper bodies still flailed in that direction. As a result of their positions, both lap-belted occupants would have been vulnerable to upper body injury due to the tree intrusion.

The simulations show that their injuries would probably have been greater if the occupants of row 8 had not been restrained by the lap/shoulder belts. Therefore, the NTSB concludes that the properly worn lap/shoulder belts of the two occupants of the row 8 seats most likely reduced their injuries related to upper body flailing, which are commonly seen when occupants are restrained
